**Flood Control Project Maintenance  
Levee Inspections**

## Maintenance Issue Types Only, Levee Inspection Report By Mile - Spring 2017

### Reclamation District No. 1602 Del Puerto

Waterway	Bank	Unit Miles	Inspection Start/End	Inspector
Unit No. 01 San Joaquin River	Left	6.24	04/06/2017 04/06/2017	Pavel Kazi

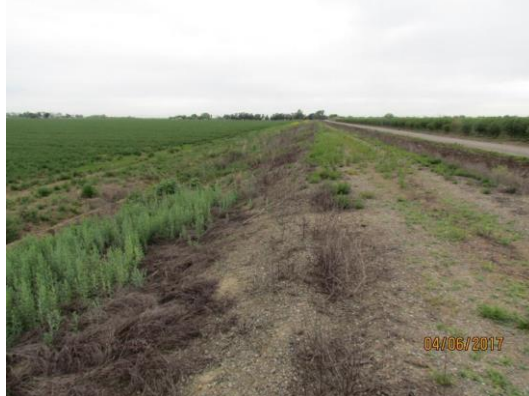
Photo 1 of 1 : SP\_2017\_RD1602\_110\_16\_20170410\_00091.jpg

LM Start	0.13	Rating **	M	Issue No.	16
LM End	0.60	Issue Type +	Ma	Location *	WS
Category	Earthen Levee			GPS Latitude/Longitude	
				Start	End
Item	Vegetation			37.477228 °	37.479964 °
				-121.081733 °	-121.074593 °
DWR ID	DWR_RD1602_01_f_2016_16				
Comment Code					
V1 : Control annual grass and weeds on the levee slopes and easements.					
Inspector Comment

View of the vegetation on the waterside of the levee. Spring 2017

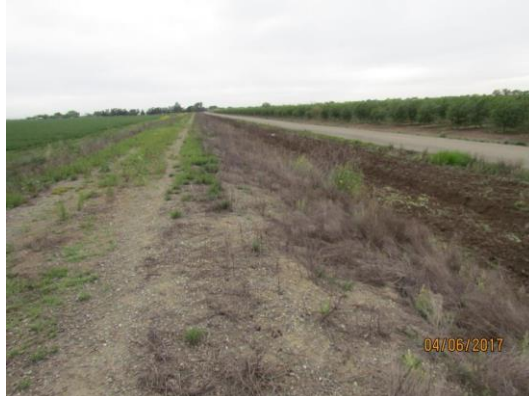
Photo 1 of 1 : SP\_2017\_RD1602\_110\_17\_20170410\_00092.jpg

LM Start	0.13	Rating **	M	Issue No.	17
LM End	0.60	Issue Type +	Ma	Location *	LS
Category	Earthen Levee			GPS Latitude/Longitude	
				Start	End
Item	Vegetation			37.477228 °	37.479964 °
				-121.081733 °	-121.074593 °
DWR ID	DWR_RD1602_01_f_2016_17				
Comment Code					
V1 : Control annual grass and weeds on the levee slopes and easements.					
Inspector Comment

View of the vegetation on the landside of the levee. Spring 2017

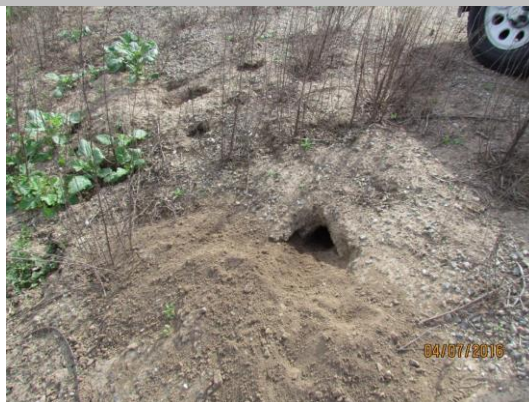
Photo 1 of 2 : SP\_2017\_RD1602\_110\_28\_20170327\_00013.jpg

Updated picture of the rodent hole on the waterside of the levee during spring 2016 inspection.

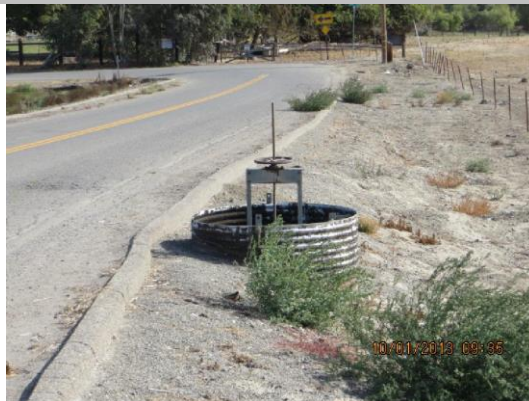
Photo 1 of 3 : UCIP\_SP\_2017\_51325\_36702.jpg

FS\_ID:51325  
DS\_ID:20215  
EP\_NO: N/A  
Repair Type: No Action Needed  
Crossing Status: Found  
UCIP Comments: 11/18/2016 Crossing has been downgraded from Urgent to No Action Needed a cover has been added to the CMP riser. (O. Magana - DWR UCIP)10/01/2013 Open 60-inch CMP riser on WS needs lid as it's depth may be a hazard to the public. (W. Wylie - DWR UCIP)  
FIELD\_STRUCT\_DESC: 16-inch steel drainage pipe through levee, 11.3 feet below crown. Slide gate in 60-inch corrugated metal pipe (CMP) riser located on the waterside (WS). Concrete inlet is approximately 110 feet west of the levee crown or 110 feet off landside (LS) toe next to roadway. [Additional Reference(s): DWR Levee Log, 1992. USACE San Joaquin River O&M Manual Unit 13, April 1964, (HLM 0.58), Drawing No. 7-4-1784].  
FS Date: 11/18/2016

60-inch CMP riser on WS shoulder.

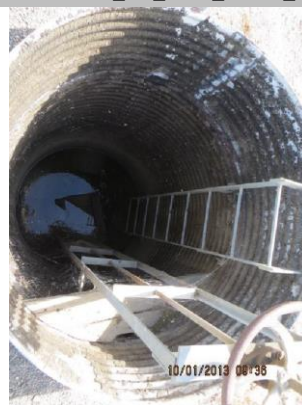
Photo 2 of 3 : UCIP\_SP\_2017\_51325\_36701.jpg

CMP riser with slide gate on WS shoulder.

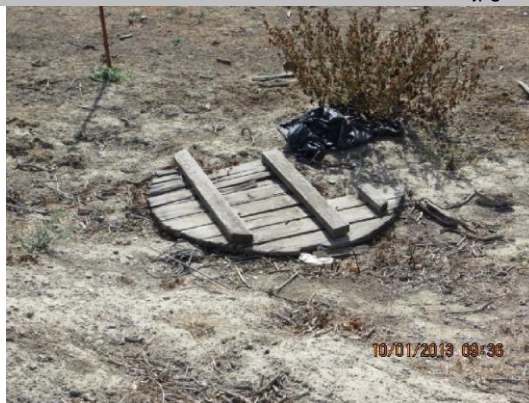
Photo 3 of 3 : UCIP\_SP\_2017\_51325\_36700.jpg

Item	DWR UCIP LMA Responsibility			37.480182 °	37.480182 °	
				-121.074765 °	-121.074765 °	
DWR ID						
Comment Code						
Inspector Comment						
FS_ID:51325 DS_ID:20215 EP_NO: N/A Repair Type: No Action Needed Crossing Status: Found UCIP Comments: 11/18/2016 Crossing has been downgraded from Urgent to No Action Needed a cover has been added to the CMP riser. (O. Magana - DWR UCIP)10/01/2013 Open 60-inch CMP riser on WS needs lid as it's depth may be a hazard to the public. (W. Wylie - DWR UCIP) FIELD_STRUCT_DESC: 16-inch steel drainage pipe through levee, 11.3 feet below crown. Slide gate in 60-inch corrugated metal pipe (CMP) riser located on the waterside (WS). Concrete inlet is approximately 110 feet west of the levee crown or 110 feet off landside (LS) toe next to roadway. [Additional Reference(s): DWR Levee Log, 1992. USACE San Joaquin River O&M Manual Unit 13, April 1964, (HLM 0.58), Drawing No. 7-4-1784]. FS Date: 11/18/2016

Damaged Wooden lid on WS toe.

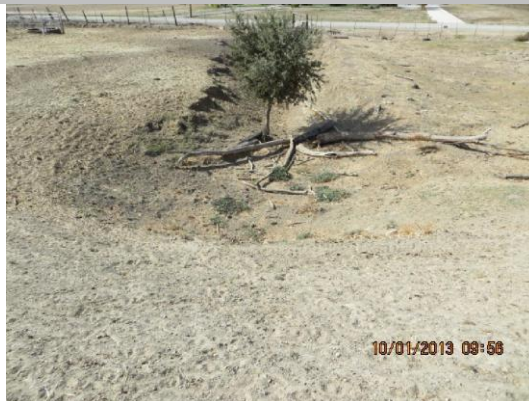
Photo 1 of 3 : UCIP\_SP\_2017\_51634\_36723.jpg

FS\_ID:51634  
DS\_ID:20216  
EP\_NO: N/A  
Repair Type: No Action Needed  
Crossing Status: Found  
UCIP Comments: 11/18/2016 Crossing has been downgraded from Urgent to No Action Needed the debris blocking the outlet has been cleared. (O. Magana - DWR UCIP)10/01/2013 Flap gate blocked from functioning by soil buildup on WS toe. Soil should be cleared. (W. Wylie - DWR UCIP)  
FIELD\_STRUCT\_DESC: 30-inch square reinforced concrete box culvert through levee, 14.4 feet below crown. Concrete "U" headwall on the waterside (WS) and landside (LS) ends. Slide gate in 6-foot by 7-foot concrete surge box is located on the WS shoulder. Flap gate is located on the WS end. [Additional Reference(s): DWR Levee Log, 1992. USACE San Joaquin River O&M Manual Unit 13, April 1964, (HLM 0.78), Drawing No. 7-4-1784].  
FS Date: 11/18/2016

Inlet on LS toe.

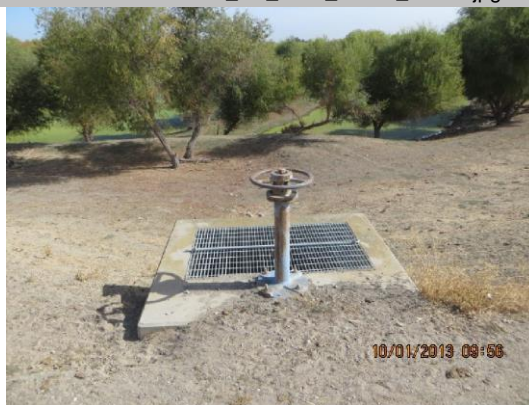
Photo 2 of 3 : UCIP\_SP\_2017\_51634\_36722.jpg

Slide gate in concrete box on WS shoulder.

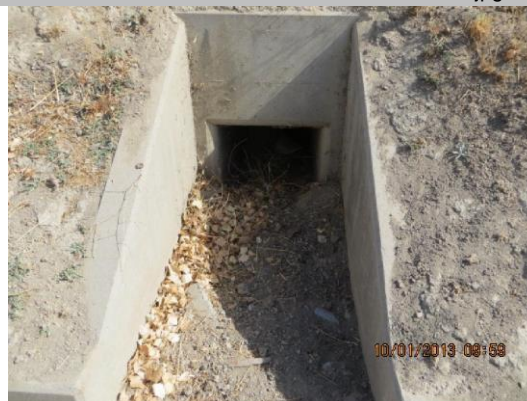
Photo 3 of 3 : UCIP\_SP\_2017\_51634\_36721.jpg

FS\_ID:51634  
DS\_ID:20216  
EP\_NO: N/A  
Repair Type: No Action Needed  
Crossing Status: Found  
UCIP Comments: 11/18/2016 Crossing has been downgraded from Urgent to No Action Needed the debris blocking the outlet has been cleared. (O. Magana - DWR UCIP)10/01/2013 Flap gate blocked from functioning by soil buildup on WS toe. Soil should be cleared. (W. Wylie - DWR UCIP)  
FIELD\_STRUCT\_DESC: 30-inch square reinforced concrete box culvert through levee, 14.4 feet below crown. Concrete "U" headwall on the waterside (WS) and landside (LS) ends. Slide gate in 6-foot by 7-foot concrete surge box is located on the WS shoulder. Flap gate is located on the WS end. [Additional Reference(s): DWR Levee Log, 1992. USACE San Joaquin River O&M Manual Unit 13, April 1964, (HLM 0.78), Drawing No. 7-4-1784].  
FS Date: 11/18/2016

Concrete inlet on LS toe.

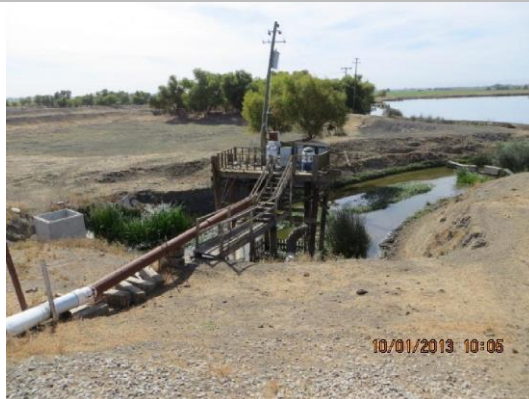
Photo 1 of 3 : UCIP\_SP\_2017\_51636\_36758.jpg

FS\_ID:51636  
DS\_ID:20217  
EP\_NO: N/A  
Repair Type: Non-Urgent  
Crossing Status: Found  
UCIP Comments: 11/18/2016 Crossing has been downgraded from Urgent to Non-Urgent a flap gate has been added to the WS but pipe is currently not connected to pump. According to Tony Martinez, LMA representative, this crossing is currently not in use. Owner will need to coordinate with CVFPB to obtain permit. (O. Magana - DWR UCIP)10/01/2013 Appears abandoned and if so should be done so properly. Flapgate missing. (W. Wylie - DWR UCIP)  
FIELD\_STRUCT\_DESC: \*ABANDONED\* 1 of 2: 16-inch steel drainage pipe through levee, 17 feet below crown. Pumps on the pump platform are located on the landside (LS). Siphon breaker in 24-inch corrugated metal pipe (CMP) riser is located on the waterside (WS) shoulder. Concrete "U" headwall and flap gate are located on the WS end.  
[Additional Reference(s): DWR Levee Log, 1992. USACE San Joaquin River O&M Manual Unit 13, April 1964, (HLM 1.01), Drawing No. 7-4-1784].

Pumping plant on LS toe. Pipe visible under walkway.

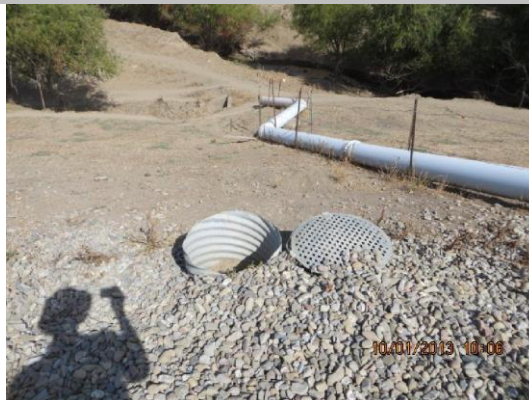
Photo 2 of 3 : UCIP\_SP\_2017\_51636\_36757.jpg

Siphon breaker in 24-inch CMP riser on WS shoulder.

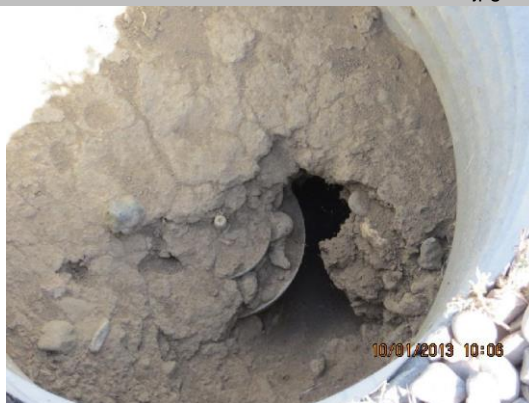
Photo 3 of 3 : UCIP\_SP\_2017\_51636\_36756.jpg

FS\_ID:51636  
DS\_ID:20217  
EP\_NO: N/A  
Repair Type: Non-Urgent  
Crossing Status: Found  
UCIP Comments: 11/18/2016 Crossing has been downgraded from Urgent to Non-Urgent a flap gate has been added to the WS but pipe is currently not connected to pump. According to Tony Martinez, LMA representative, this crossing is currently not in use. Owner will need to coordinate with CVFPB to obtain permit. (O. Magana - DWR UCIP)10/01/2013 Appears abandoned and if so should be done so properly. Flapgate missing. (W. Wylie - DWR UCIP)  
FIELD\_STRUCT\_DESC: \*ABANDONED\* 1 of 2: 16-inch steel drainage pipe through levee, 17 feet below crown. Pumps on the pump platform are located on the landside (LS). Siphon breaker in 24-inch corrugated metal pipe (CMP) riser is located on the waterside (WS) shoulder. Concrete "U" headwall and flap gate are located on the WS end.  
[Additional Reference(s): DWR Levee Log, 1992. USACE San Joaquin River O&M Manual Unit 13, April 1964, (HLM 1.01), Drawing No. 7-4-1784].

Siphon breaker in 24-inch CMP riser on WS shoulder.

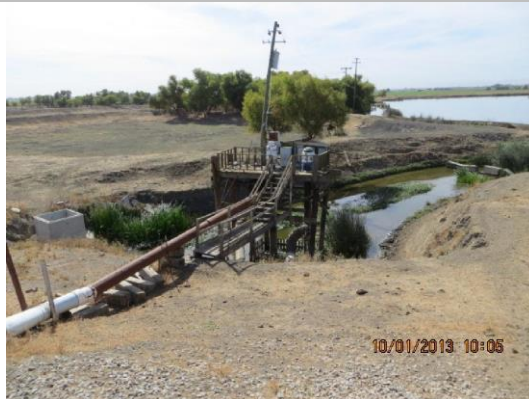
Photo 1 of 3 : UCIP\_SP\_2017\_51637\_36772.jpg

FS\_ID:51637  
DS\_ID:20219  
EP\_NO: N/A  
Repair Type: Non-Urgent  
Crossing Status: Found  
UCIP Comments: 11/18/2016 Crossing has been downgraded from Urgent to Non-Urgent a flap gate has been added to the WS. According to Tony Martinez, LMA representative, this crossing is currently not in use. Owner will need to coordinate with CVFPB to obtain permit. (O. Magana - DWR UCIP)10/01/2013 Appears abandoned siphon breakers covered in soil and flapgate missing. (W. Wylie - DWR UCIP) FIELD\_STRUCT\_DESC: \*ABANDONED\* 2 of 2: 16-inch steel drainage pipe through levee, 17 feet below crown. Pump on pump platform located on the landside (LS). Siphon breaker in 24-inch riser located on the waterside (WS) shoulder. Concrete "U" headwall and flap gate are located on the WS end. [Additional Reference(s): DWR Levee Log, 1992. USACE San Joaquin River O&M Manual Unit 13, April 1964, (HLM 1.01), Drawing No. 7-4-1784].

Pipe visible under walkway at puming plant on LS toe.

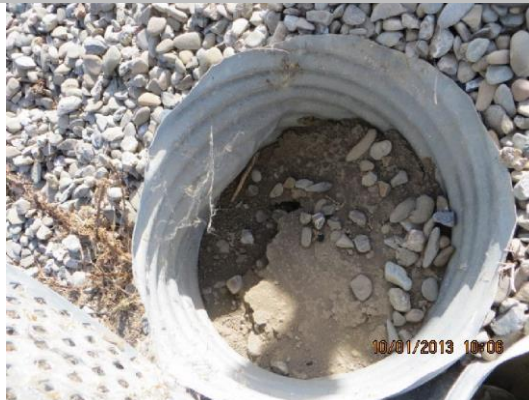
Photo 2 of 3 : UCIP\_SP\_2017\_51637\_36771.jpg

Siphon breaker covered in soil at CMP riser on WS shoulder.

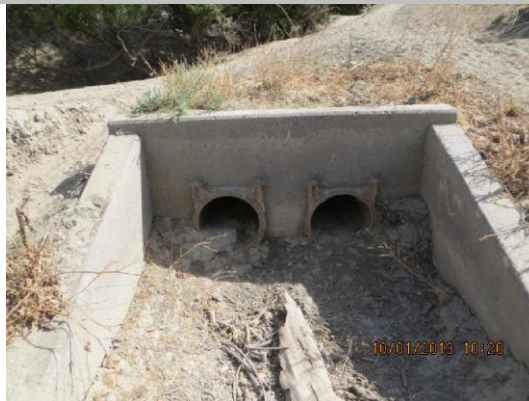
Photo 3 of 3 : UCIP\_SP\_2017\_51637\_36770.jpg

FS\_ID:51637  
DS\_ID:20219  
EP\_NO: N/A  
Repair Type: Non-Urgent  
Crossing Status: Found  
UCIP Comments: 11/18/2016 Crossing has been downgraded from Urgent to Non-Urgent a flap gate has been added to the WS. According to Tony Martinez, LMA representative, this crossing is currently not in use. Owner will need to coordinate with CVFPB to obtain permit. (O. Magana - DWR UCIP)10/01/2013 Appears abandoned siphon breakers covered in soil and flapgate missing. (W. Wylie - DWR UCIP) FIELD\_STRUCT\_DESC: \*ABANDONED\* 2 of 2: 16-inch steel drainage pipe through levee, 17 feet below crown. Pump on pump platform located on the landside (LS). Siphon breaker in 24-inch riser located on the waterside (WS) shoulder. Concrete "U" headwall and flap gate are located on the WS end. [Additional Reference(s): DWR Levee Log, 1992. USACE San Joaquin River O&M Manual Unit 13, April 1964, (HLM 1.01), Drawing No. 7-4-1784].

Concrete headwall on WS toe with missing flapgate.

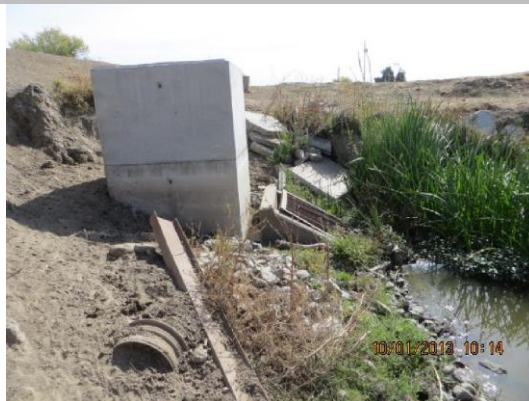
Photo 1 of 3 : UCIP\_SP\_2017\_51329\_36786.jpg

FS\_ID:51329  
DS\_ID:20218  
EP\_NO: N/A  
Repair Type: Urgent  
Crossing Status: Found  
UCIP Comments: 11/18/2016 Same as previous inspection headwall on the WS toe has separated from pipe and flap gate is still missing. Erosion around concrete headwall and undermined WS slope are visible from WS. The slope undermined appears to have progressed but no photos were taken due to the dense vegetation covering area. According to Tony Martinez, LMA representative, the WS concrete headwall has been detached since 2008/2009. LMA has been in contact with CVFPB, DWR, and USACE regarding this site. (O. Magana - DWR UCIP)10/01/2013 Headwall on WS toe separated from pipe. Erosion around concrete headwall and undermined at WS toe. Flap gate missing from WS toe headwall. (W. Wylie - DWR UCIP) FIELD\_STRUCT\_DESC: 30-inch square reinforced concrete box culvert through levee, 25.4 feet below crown. Concrete "U" headwalls on both waterside (WS) and landside (LS) ends. Slide gate in concrete surge box located on the WS slope. A 5-foot by 5-foot concrete box is located on LS toe. Flap gate is located on the WS end. [Additional Reference(s): DWR Levee Log, 1992. USACE San Joaquin River O&M Manual Unit 13, April 1964, (HLM 1.02), Drawing No. 7-4-1784]. FS Date: 11/18/2016

Grated inlet and 5'X5' concrete box on LS toe.

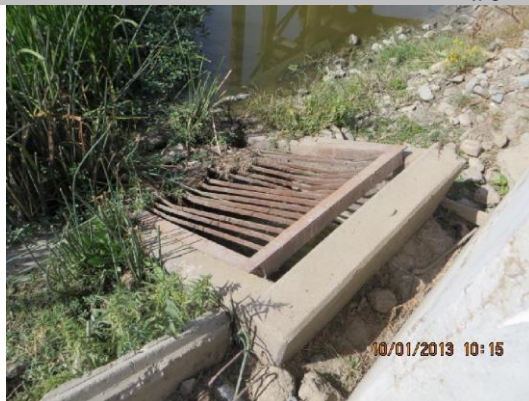
Photo 2 of 3 : UCIP\_SP\_2017\_51329\_36785.jpg

Grated inlet at LS toe.

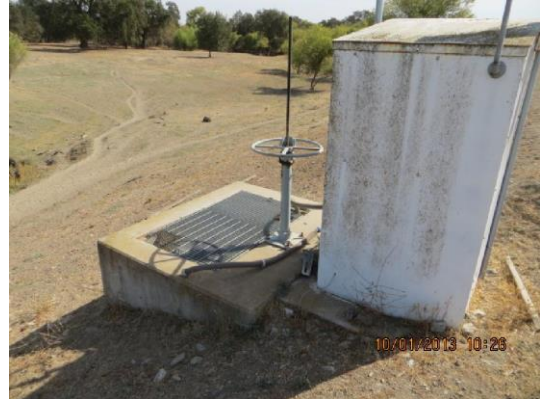
Photo 3 of 3 : UCIP\_SP\_2017\_51329\_36789.jpg

Slide gate in concrete riser next to shed on WS shoulder.

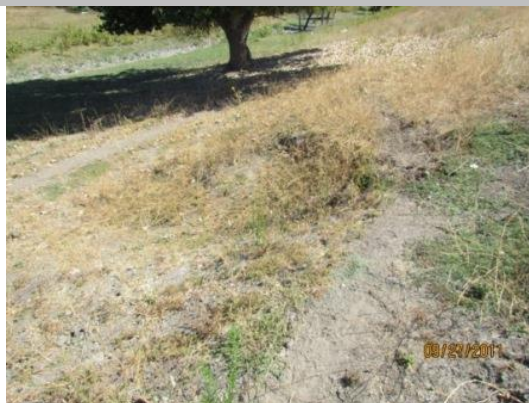
Photo 1 of 2 : SP\_2017\_RD1602\_110\_37\_20170327\_00019.jpg

LM Start	1.05	Rating **	M	Issue No.	37
LM End	1.05	Issue Type +	Ma	Location *	WS
Category	Earthen Levee			GPS Latitude/Longitude	
				Start	End
Item	Slope Stability			37.478567 °	37.478567 °
				-121.067847 °	-121.067847 °
DWR ID	DWR_RD1602_01_s_2012_37				
Comment Code					
S1 : Repair slope instability.					
Inspector Comment					
Small amount of slumping at waterside toe of the levee.

View of the depression at the waterside toe of the levee. The picture was taken from the crown of the levee looking upstream during fall 2011 inspection.

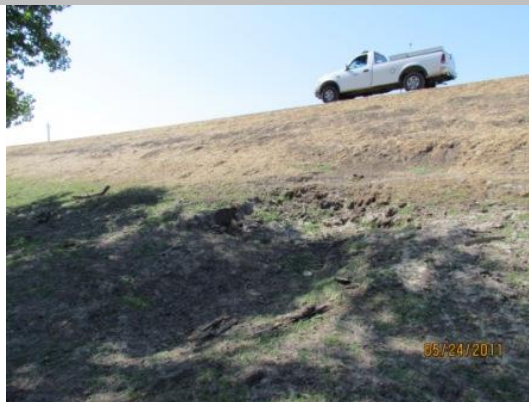
Photo 2 of 2 : SP\_2017\_RD1602\_110\_37\_20170327\_00020.jpg

Depression at the waterside slope of the levee during Spring 2011 inspection.

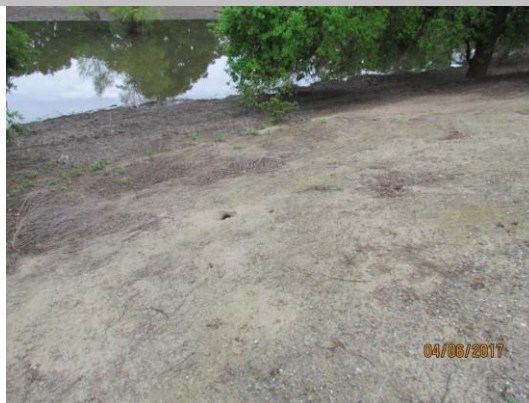
Photo 1 of 1 : SP\_2017\_RD1602\_110\_55\_20170410\_00093.jpg

View of a rodent hole on the waterside slope of the levee.

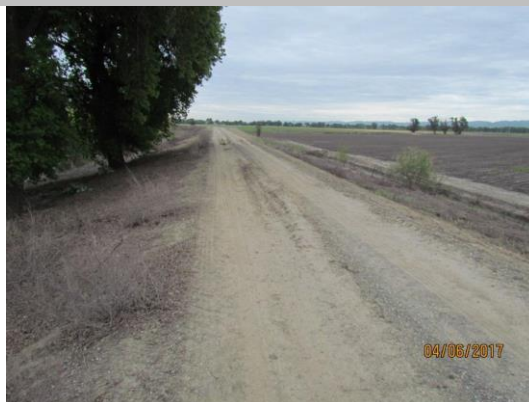
Photo 1 of 1 : SP\_2017\_RD1602\_110\_76\_20170410\_00094.jpg

LM Start	1.89	Rating **	M	Issue No.	76
LM End	1.89	Issue Type +	Ma	Location *	CR
Category	Earthen Levee			GPS Latitude/Longitude	
				Start	End
Item	Crown Surface / Depressions / Rutting			37.473718 °	37.473718 °
				-121.057926 °	-121.057926 °
DWR ID	DWR_RD1602_01_s_2017_76				
Comment Code					
C2 : Repair depressions or ruts in the crown or slope.					
Inspector Comment

View of crown depression on the levee looking upstream.

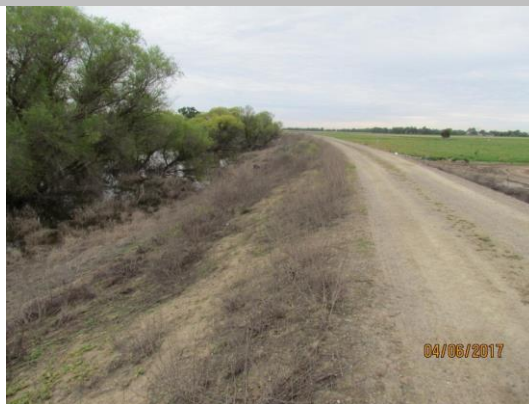
Photo 1 of 1 : SP\_2017\_RD1602\_110\_78\_20170410\_00095.jpg

View of the vegetation on the waterside of the levee.

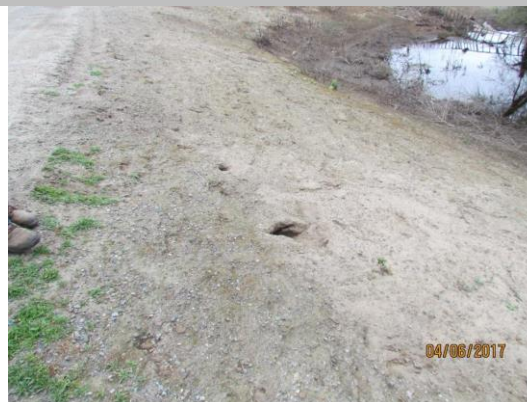
Photo 1 of 1 : SP\_2017\_RD1602\_110\_81\_20170410\_00096.jpg

View of a rodent hole on the waterside slope of the levee.

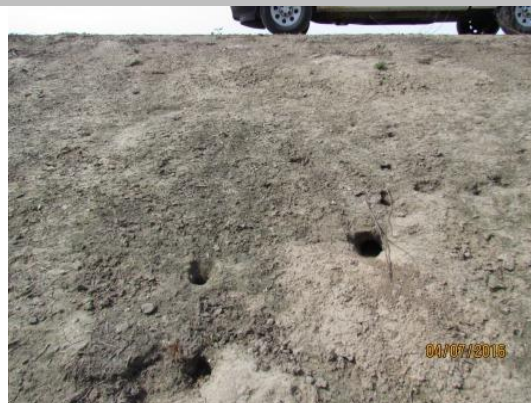
Photo 1 of 1 : SP\_2017\_RD1602\_110\_19\_20170327\_00006.jpg

View of rodent holes on the waterside of the levee.

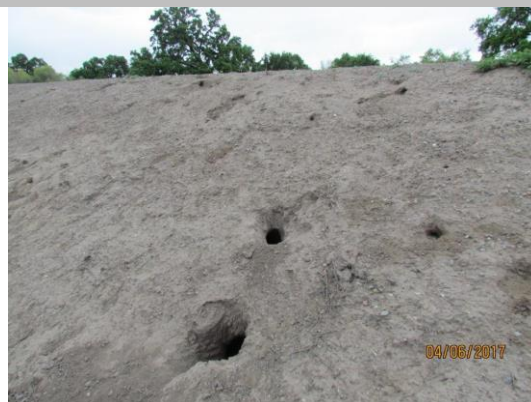
Photo 1 of 2 : SP\_2017\_RD1602\_110\_40\_20170410\_00097.jpg

Updated picture of the rodent holes on the landside of the levee during spring 2017 inspection.

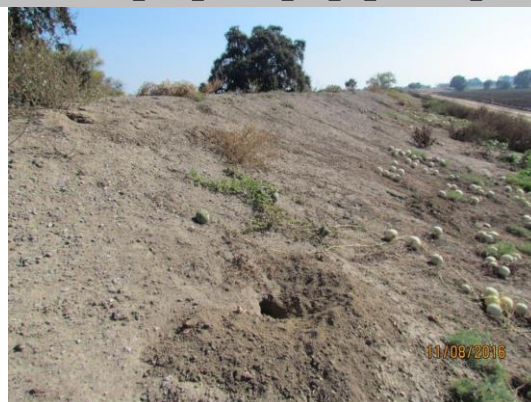
Photo 2 of 2 : SP\_2017\_RD1602\_110\_40\_20170327\_00021.jpg

View of rodent hole on the landside of the levee. Fall 2016

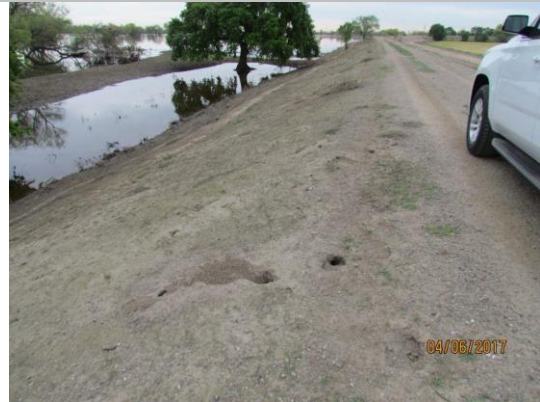
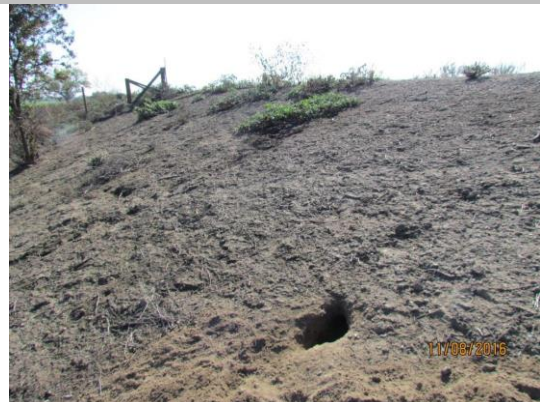
Photo 1 of 1 : SP\_2017\_RD1602\_110\_82\_20170410\_00098.jpg

View of rodent holes on the waterside slope of the levee. Fall 2016

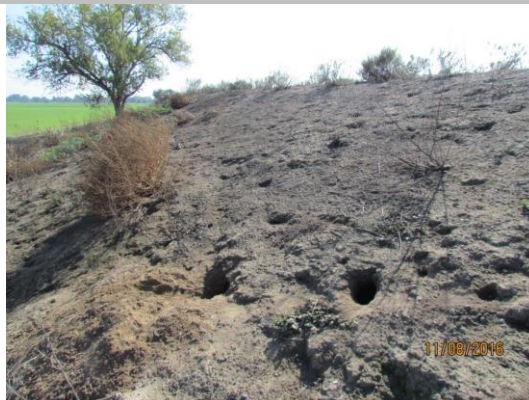
Photo 1 of 1 : SP\_2017\_RD1602\_110\_47\_20170327\_00026.jpg

View of rodent holes on the waterside of the levee. Fall 2016

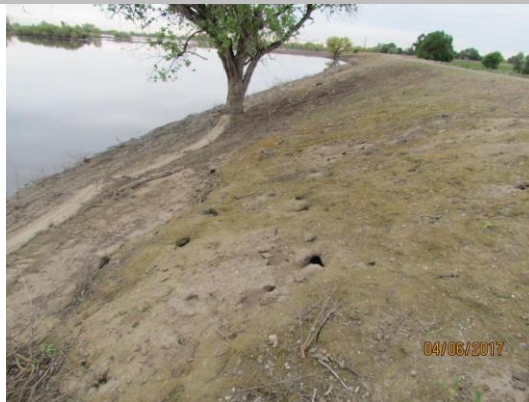
Photo 1 of 1 : SP\_2017\_RD1602\_110\_49\_20170410\_00099.jpg

View of rodent holes on the waterside slope of the levee. Spring 2017

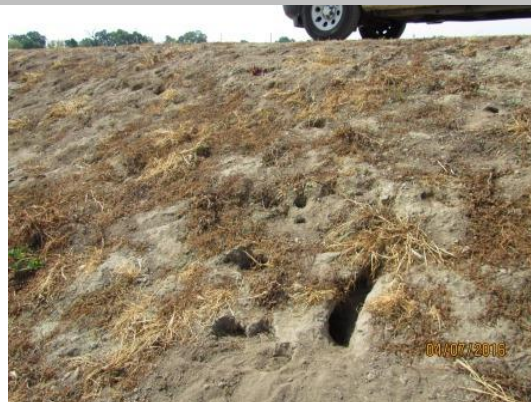
Photo 1 of 1 : SP\_2017\_RD1602\_110\_24\_20170327\_00010.jpg

View of rodent holes on the waterside of the levee looking upstream.

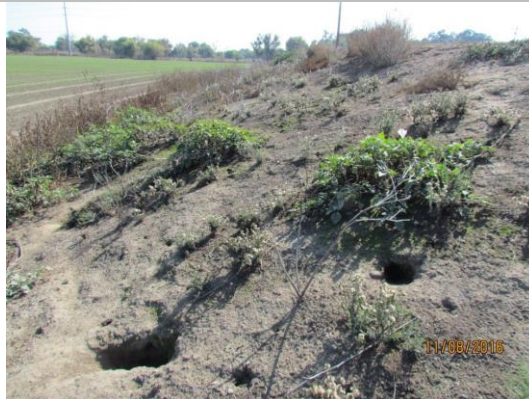
Photo 1 of 1 : SP\_2017\_RD1602\_110\_25\_20170327\_00011.jpg

View of rodent holes on the waterside toe of the levee looking upstream.  
Fall 2016

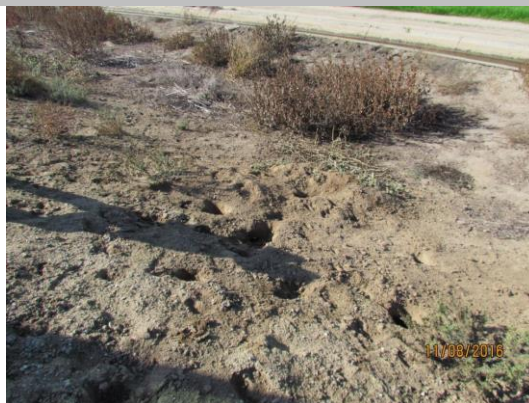
Photo 1 of 1 : SP\_2017\_RD1602\_110\_56\_20170327\_00031.jpg

View of rodent holes on the landside of the levee. Fall 2016

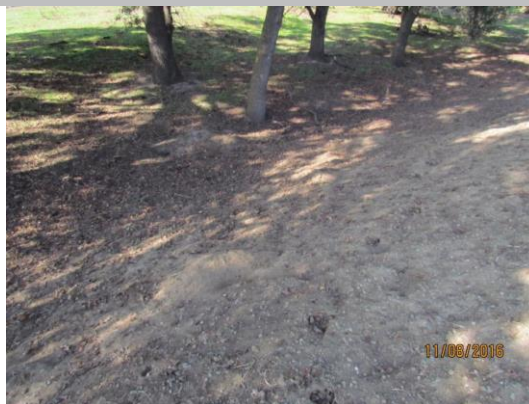
Photo 1 of 1 : SP\_2017\_RD1602\_110\_60\_20170327\_00033.jpg

View of rodent hole on the landside toe of the levee. Fall 2016

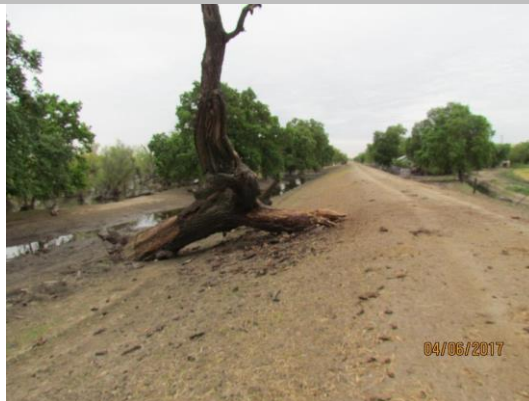
Photo 1 of 1 : SP\_2017\_RD1602\_110\_83\_20170410\_00100.jpg

View of a tree trunk on the waterside slope of the levee.

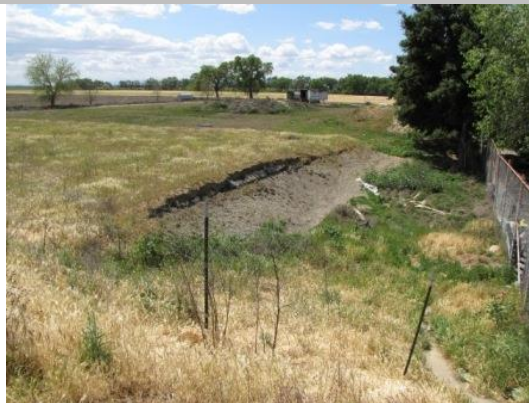
Photo 1 of 1 : SP\_2017\_RD1602\_110\_62\_20170327\_00035.jpg

Repair damage to USACE constructed seepage berm by pedestrian and cycle traffic.

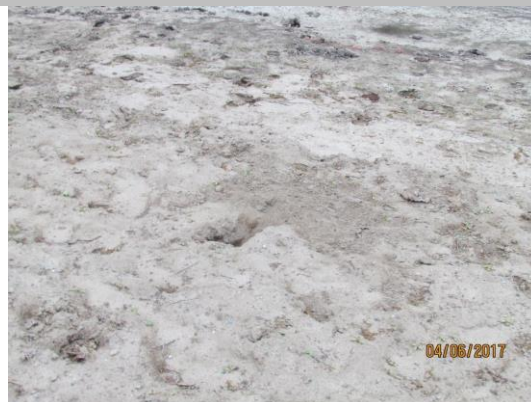
Photo 1 of 1 : SP\_2017\_RD1602\_110\_88\_20170410\_00103.jpg

View of a rodent hole on the waterside slope of the levee.

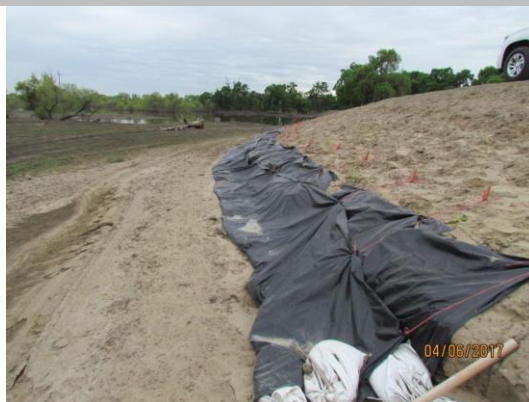
Photo 1 of 2 : SP\_2017\_RD1602\_110\_89\_20170410\_00104.jpg

View of wave wash installed by the LMA on the waterside toe of the levee. Spring 2017

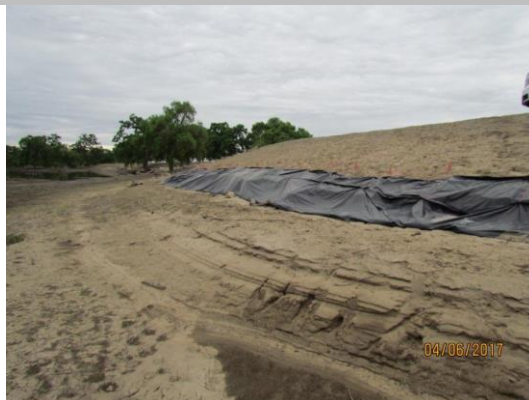
Photo 2 of 2 : SP\_2017\_RD1602\_110\_89\_20170410\_00105.jpg

Another view of wave wash installed by the LMA on the waterside toe of the levee. Spring 2017

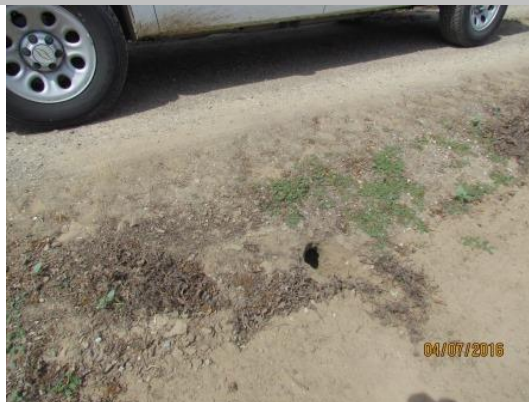
Photo 1 of 1 : SP\_2017\_RD1602\_110\_35\_20170327\_00017.jpg

View of an animal hole on the waterside shoulder of the levee looking downstream.

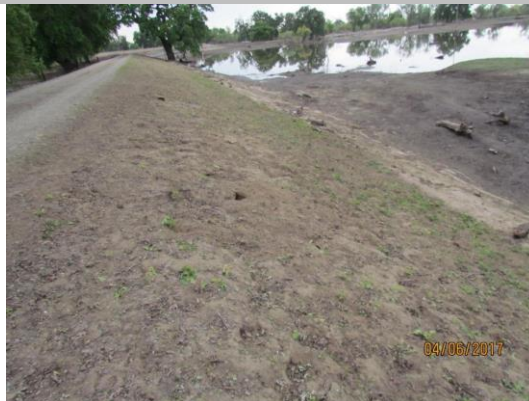
Photo 1 of 1 : SP\_2017\_RD1602\_110\_91\_20170410\_00106.jpg

View of rodent holes on the waterside of the levee looking downstream.  
Spring 2017

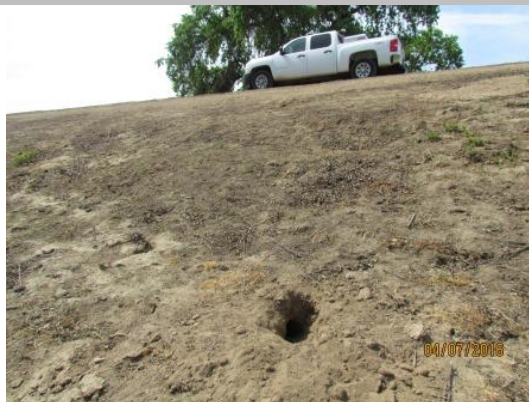
Photo 1 of 1 : SP\_2017\_RD1602\_110\_74\_20170327\_00044.jpg

View of a rodent hole on the waterside toe of the levee.

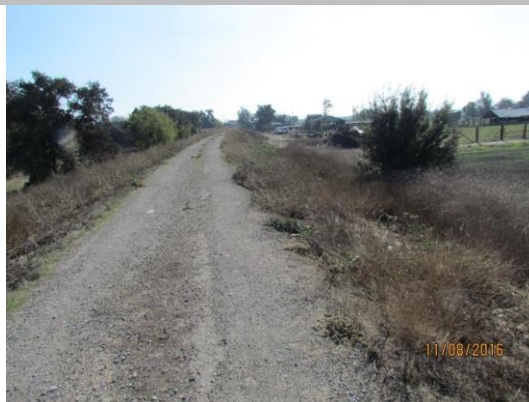
Photo 1 of 1 : SP\_2017\_RD1602\_110\_73\_20170327\_00043.jpg

View of vegetation on the landside slope of the levee. Fall 2016

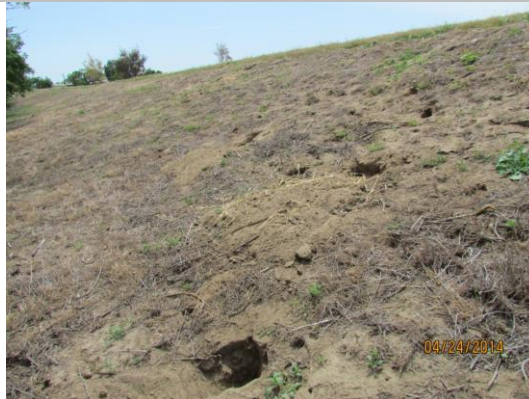
Photo 1 of 1 : SP\_2017\_RD1602\_110\_199\_20170327\_00046.jpg

Rodent holes were found on the waterside toe of the levee looking upstream.

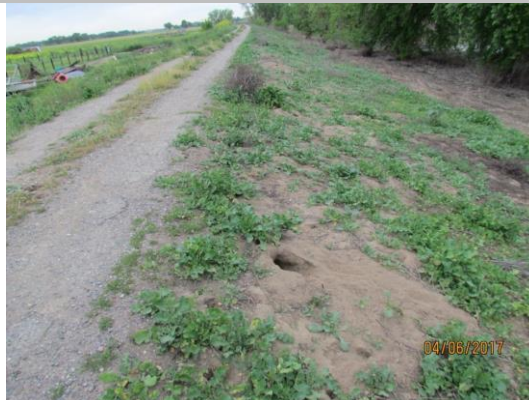
Photo 1 of 1 : SP\_2017\_RD1602\_110\_92\_20170410\_00107.jpg

View of a rodent hole on the waterside shoulder of the levee looking downstream.

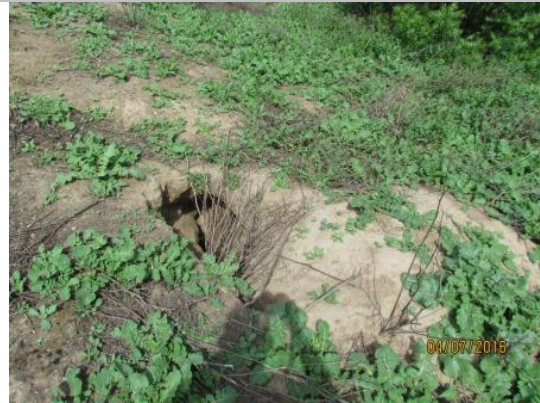
Photo 1 of 1 : SP\_2017\_RD1602\_110\_48\_20170327\_00027.jpg

View of rodent holes on the waterside of the levee looking downstream.

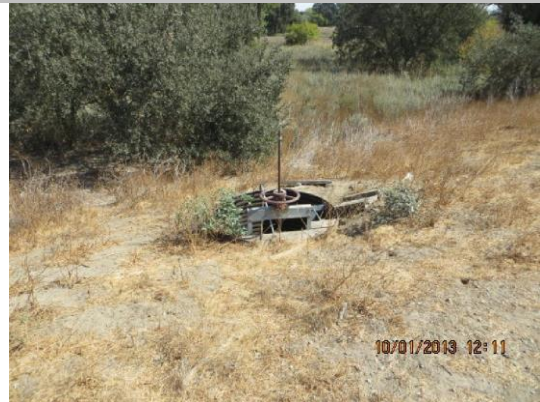
Photo 1 of 3 : UCIP\_SP\_2017\_51336\_36822.jpg

Slide gate in CMP riser on WS slope. Outlet visible under tree in background.

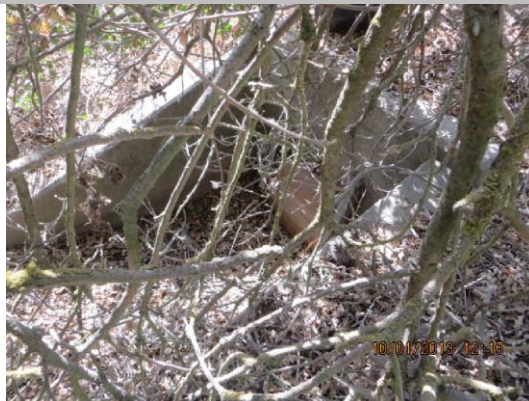
Photo 2 of 3 : UCIP\_SP\_2017\_51336\_36821.jpg

Flapgate in Concrete headwall on WS toe under tree.

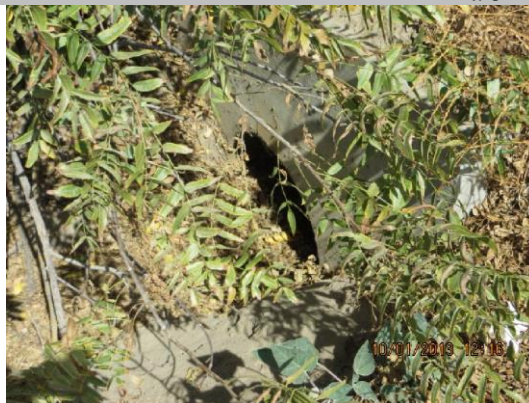
Photo 3 of 3 : UCIP\_SP\_2017\_51336\_36820.jpg

Concrete headwall at inlet on LS toe.

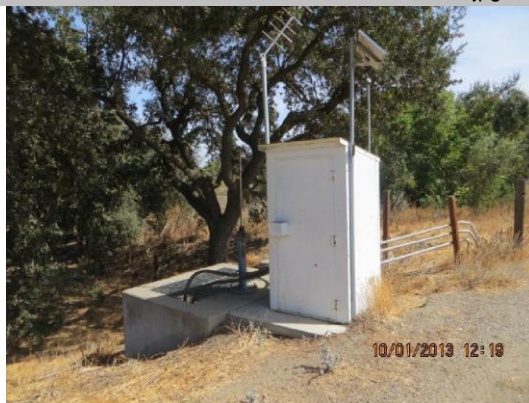
Photo 1 of 2 : UCIP\_SP\_2017\_21665\_36829.jpg

Shed with slide gate in Concrete riser on WS shoulder.

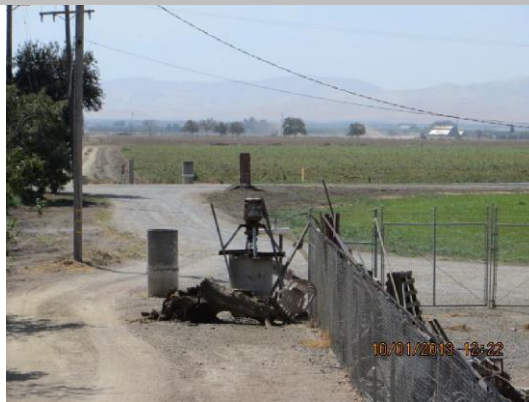
Photo 2 of 2 : UCIP\_SP\_2017\_21665\_36828.jpg

Likely risers for pipe off LS toe.

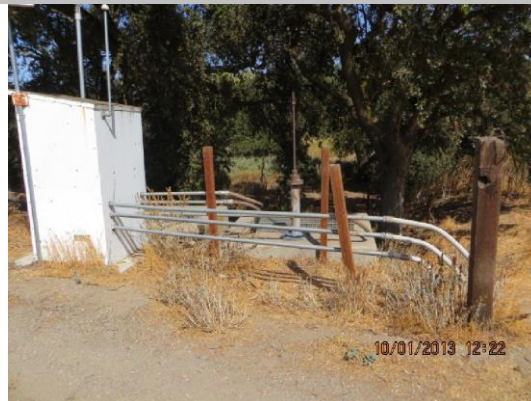
Photo 1 of 2 : UCIP\_SP\_2017\_21668\_36835.jpg

Slide gate in Concrete vault on WS shoulder.

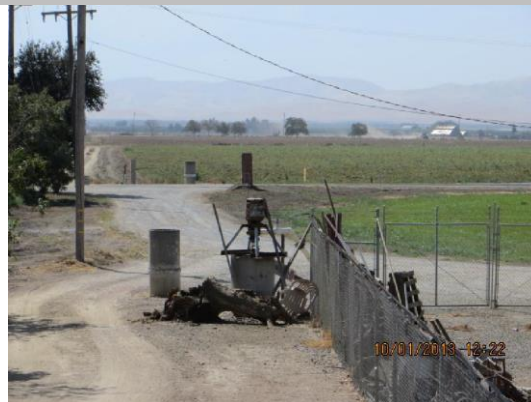
Photo 2 of 2 : UCIP\_SP\_2017\_21668\_36834.jpg

Possible concrete risers for pipe off LS toe.

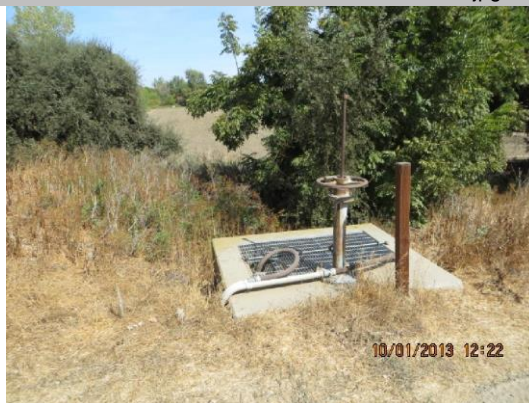
Photo 1 of 3 : UCIP\_SP\_2017\_21672\_36848.jpg

Slidegate in concrete riser on WS shoulder.

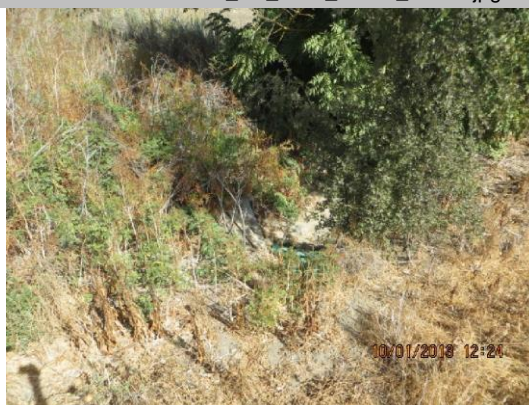
Photo 2 of 3 : UCIP\_SP\_2017\_21672\_36847.jpg

Concrete outlet on WS toe.

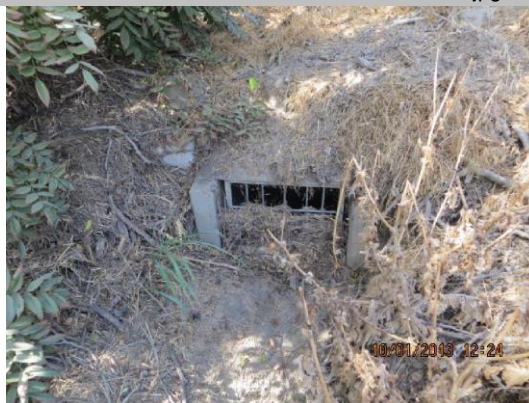
Photo 3 of 3 : UCIP\_SP\_2017\_21672\_36846.jpg

Concrete inlet on LS toe.

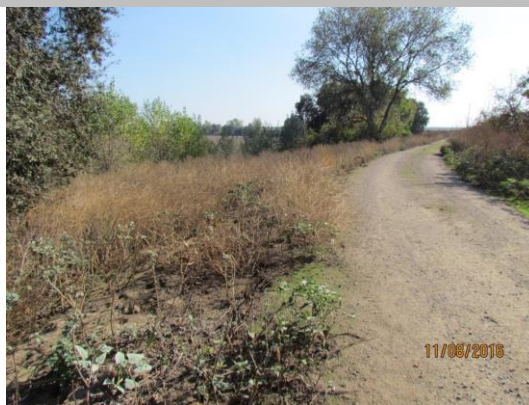
Photo 1 of 1 : SP\_2017\_RD1602\_110\_75\_20170327\_00045.jpg

Vegetation was found on the waterside slope of the levee looking upstream during fall 2016 inspection.

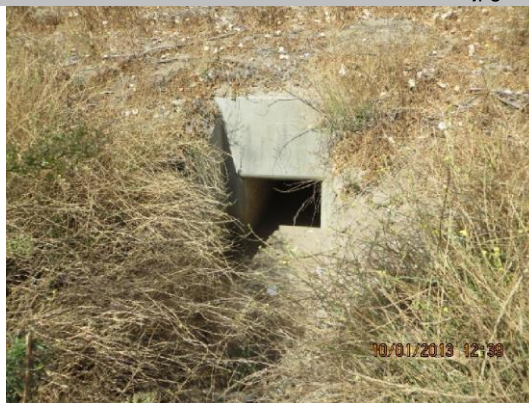
Photo 3 of 3 : UCIP\_SP\_2017\_51337\_36876.jpg

Concrete U-shaped headwall on LS toe.
